CM100 WATERPROOFING - HIGH BUILD SYSTEM

INSULATED PLAZA DECK W/ PAVERS

SYSTEM
DETAIL

CM-HB01

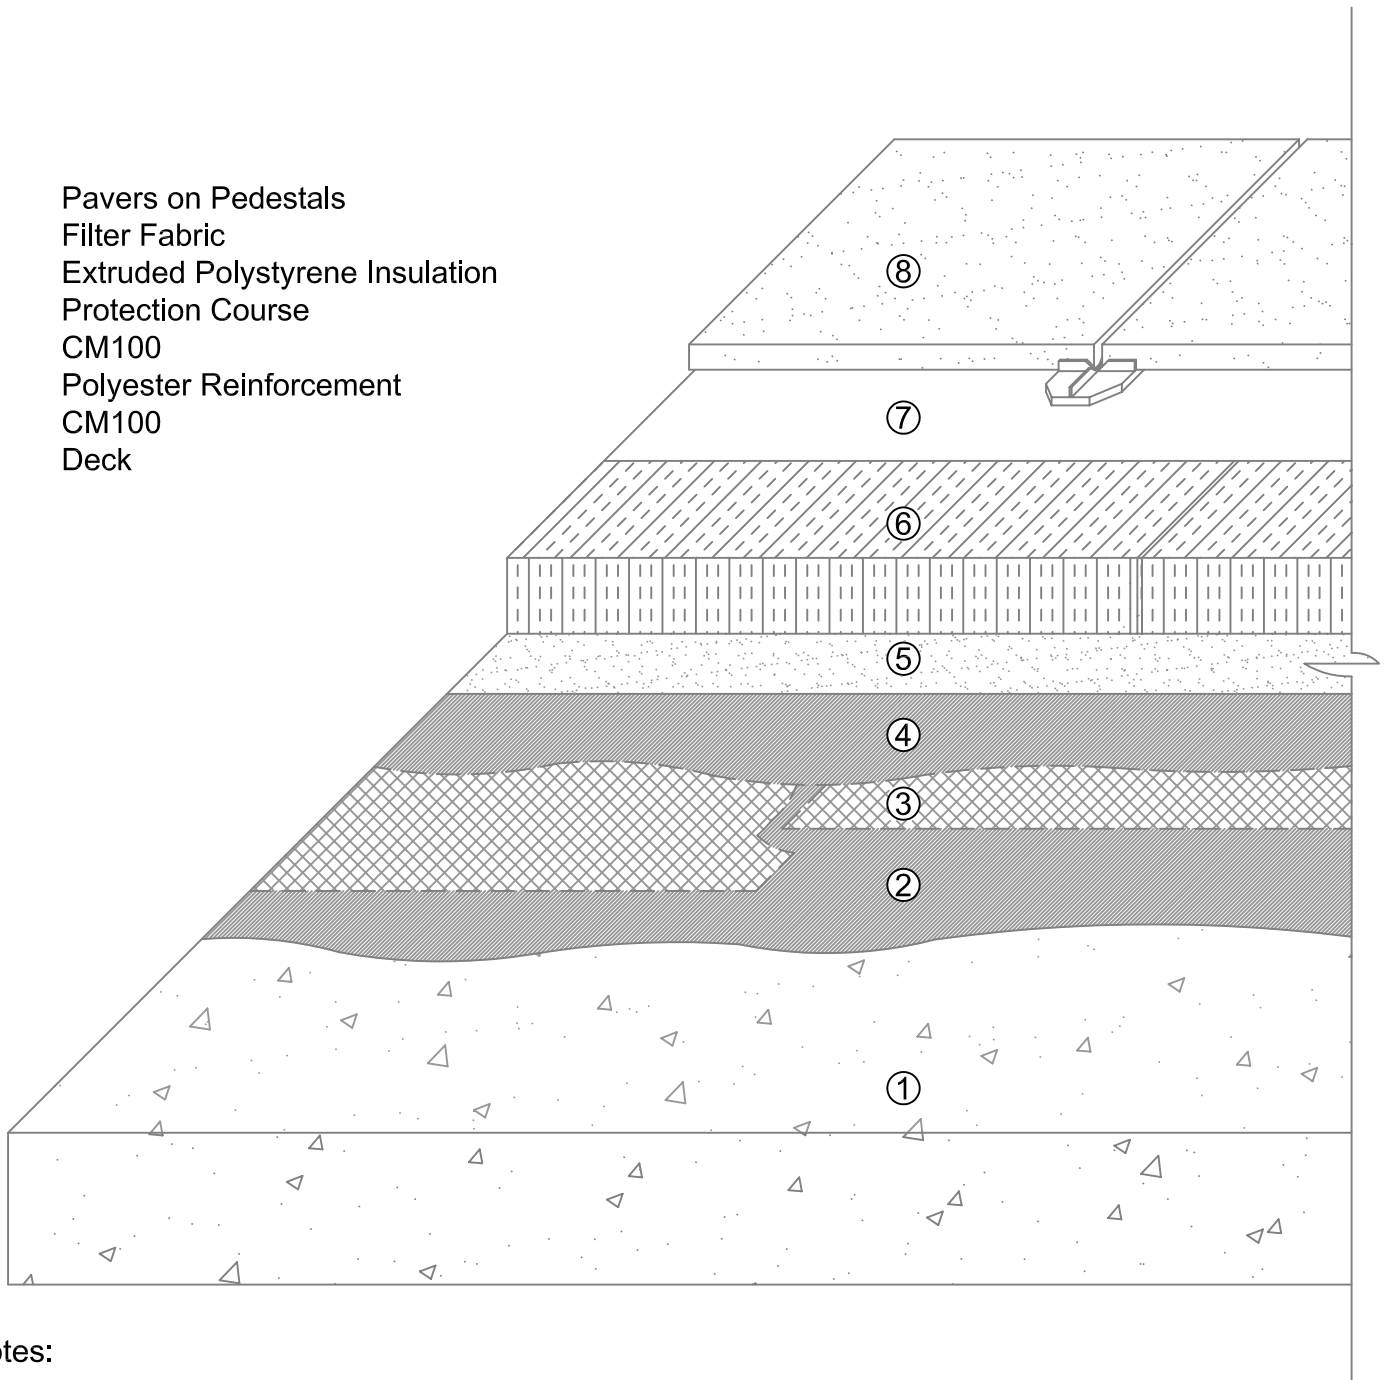
- 8. Pavers on Pedestals
- 7. Filter Fabric
- 6. Extruded Polystyrene Insulation
- 5. Protection Course
- 4. CM100
- 3. Polyester Reinforcement
- 2. CM100
- 1. Deck

- 1. Detail showing CM100, a two ply reinforced, cold-applied, fast curing waterproofing membrane system incorporating insulation and pavers.
