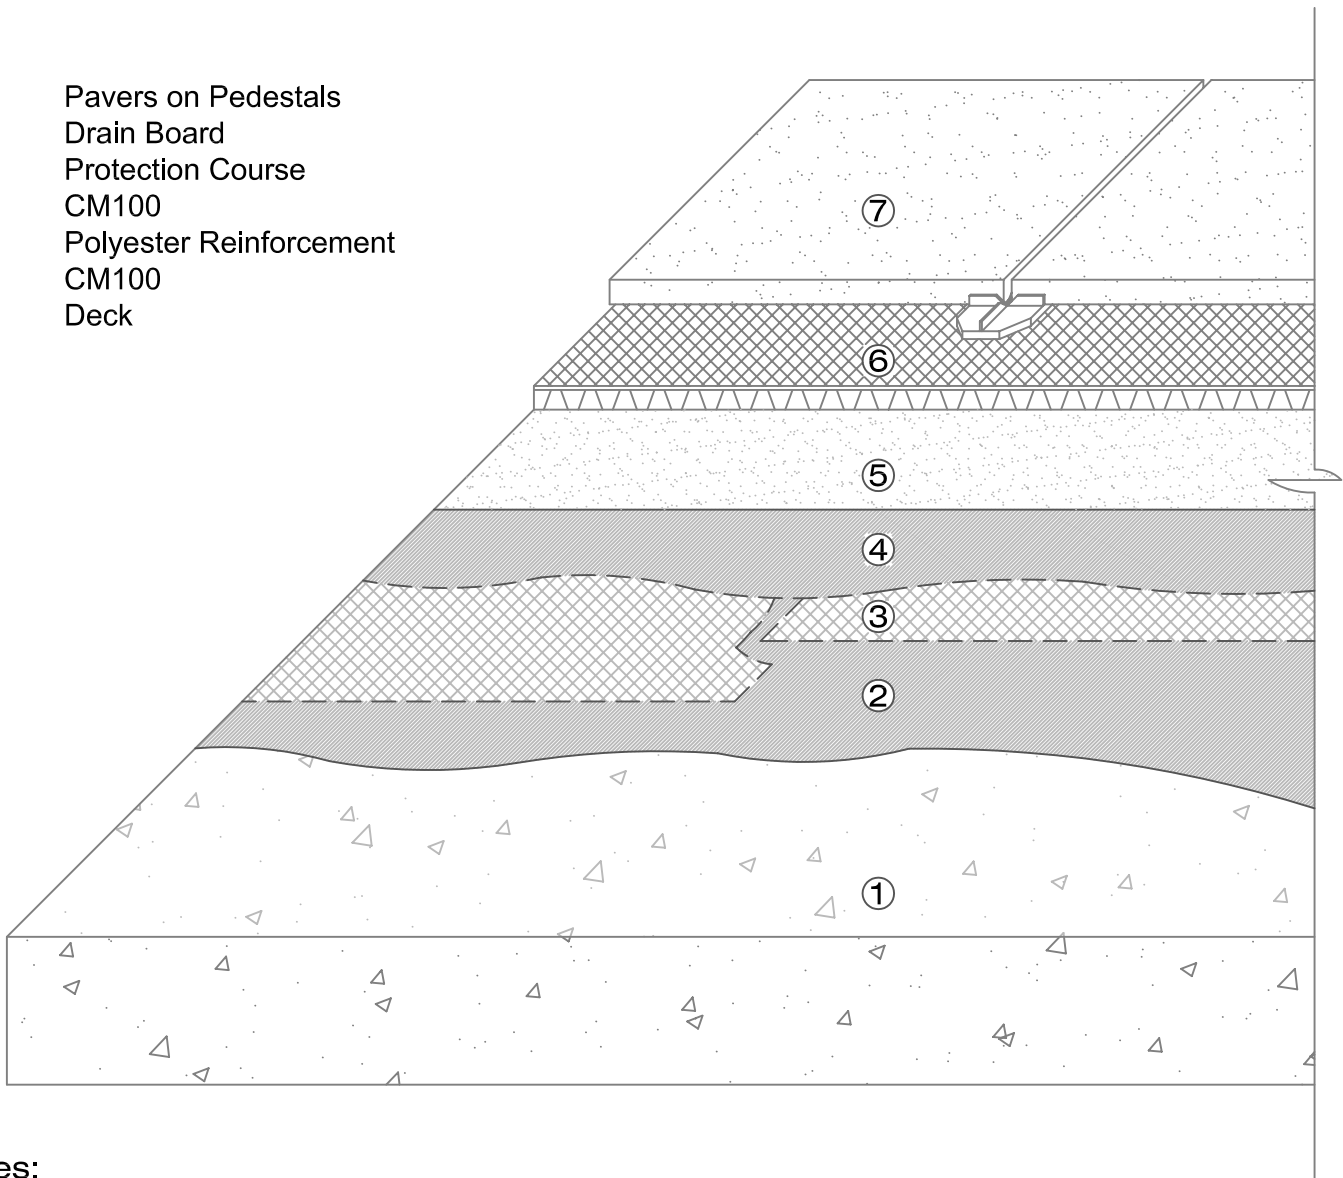
- 7. Pavers on Pedestals
- 6. Drain Board
- 5. Protection Course
- 4. CM100
- 3. Polyester Reinforcement
- 2. CM100
- 1. Deck

- 1. Detail showing CM100 , a two ply reinforced, cold-applied, fast curing waterproofing membrane system incorporating a drain board and pavers.
